DOT/FAA/DS-88/5

# AERONAUTICAL DECISION MAKING FOR AIR AMBULANCE HELICOPTER PILOTS: LEARNING FROM PAST MISTAKES

July 1988

Final Report

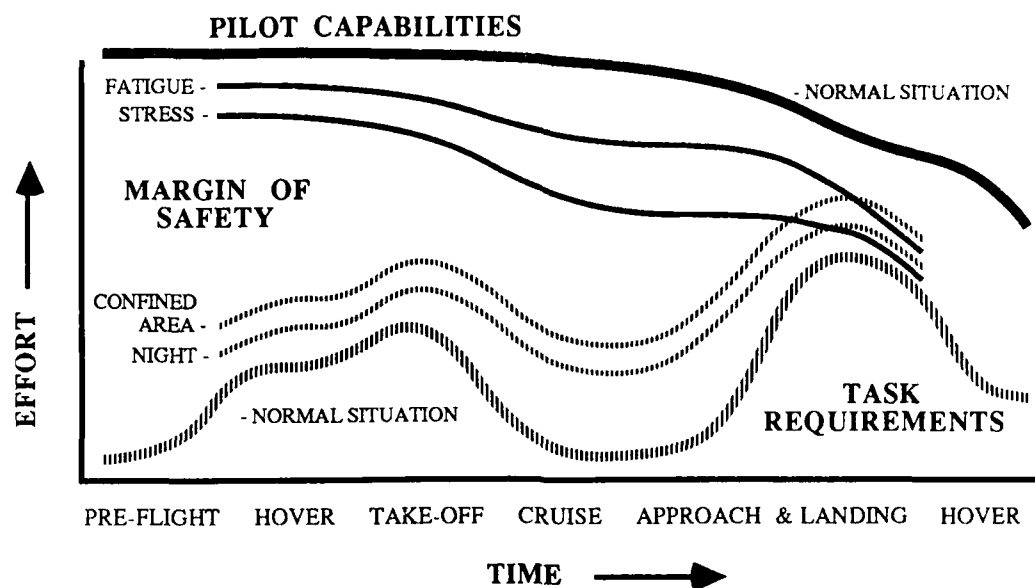
FIGURE 1

To put it bluntly, this guy was an accident looking for a place to happen. The "margin of safety" as depicted in Figure 1, was nonexistent due to extreme increase in the task requirements over the normal situation exacerbated by severe reductions in pilot capabilities.

Pilots need to learn how to recognize and be aware of the effects of stressors and other factors in any given situation that tend to reduce capabilities and/or increase workload. Good decisions will generally be the result of adjustments and alternatives selected accordingly.
